**Re: Violations of APA Permit P2016-226 by WhistlePig Whiskey
 Hamlet of Mineville, Town of Moriah, Essex County**

REPORT for
Mineville 2023

Bureau of Air Quality Surveillance
Division of Air Resources
NYS Department of Environmental Conservation
Final 03/18/2024

**Re: WhistlePig Whiskey Company warehouse emissions
52 Tom Phelps Ln
Moriah (T), Essex County**

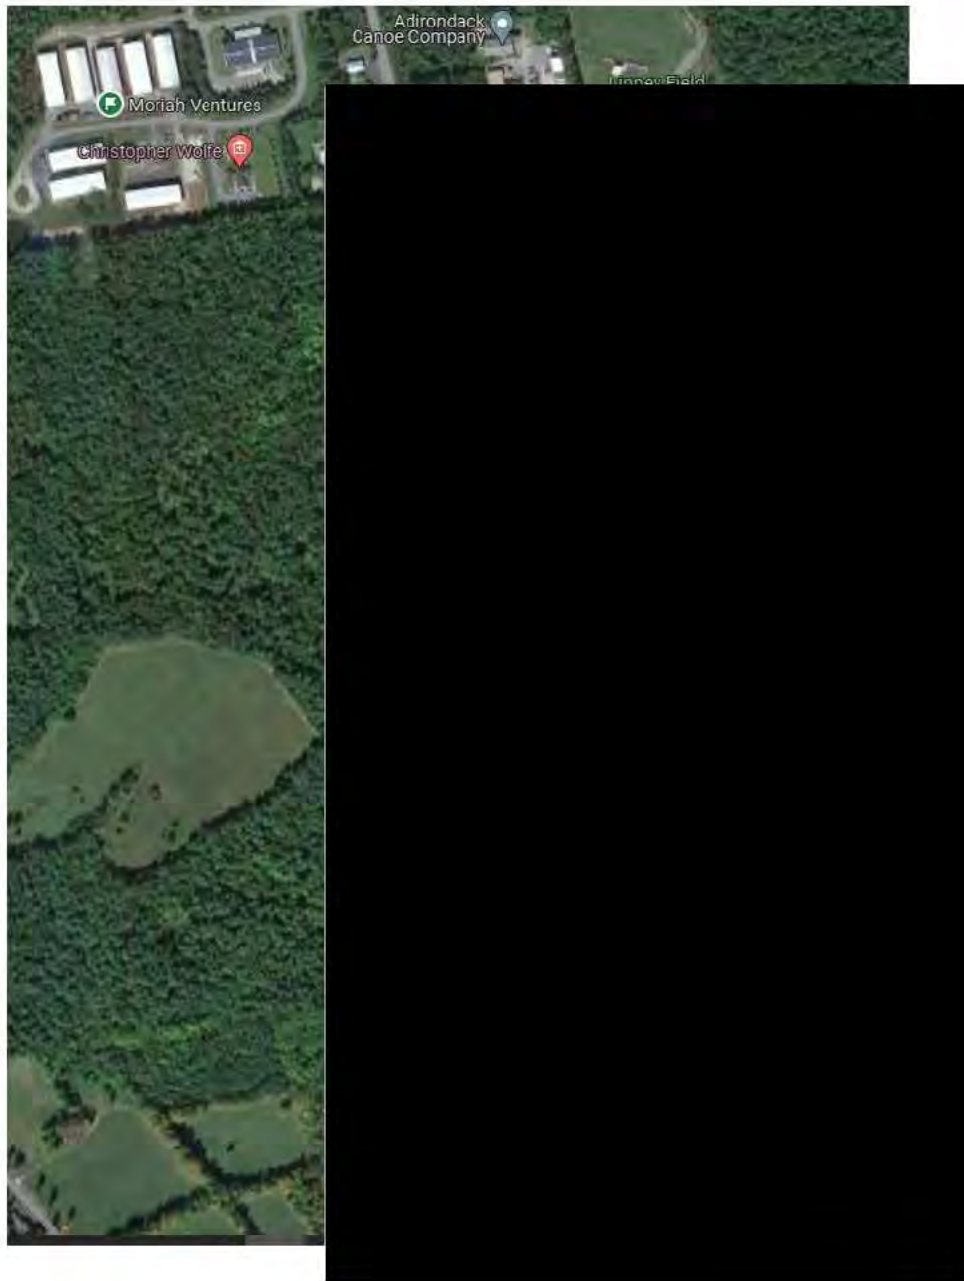
Sampling

Sample descriptions	Sample Location	Distance from WhistlePig Facility
R511923-1,	Source Sample WhistlePig	
R511923-2,	Source Sample WhistlePig	
R511923-3, 1A	[REDACTED]	663 Yards
R511923-4, 2A	[REDACTED]	796 Yards
R511923-5, 3A	[REDACTED]	961 Yards
R511923-6, 4A	[REDACTED]	1379 Yards
R511923-7	Control (not on the map, Warrensburg Office)

-The distance from WhistlePig facility was approximated by using tools available on Google Earth

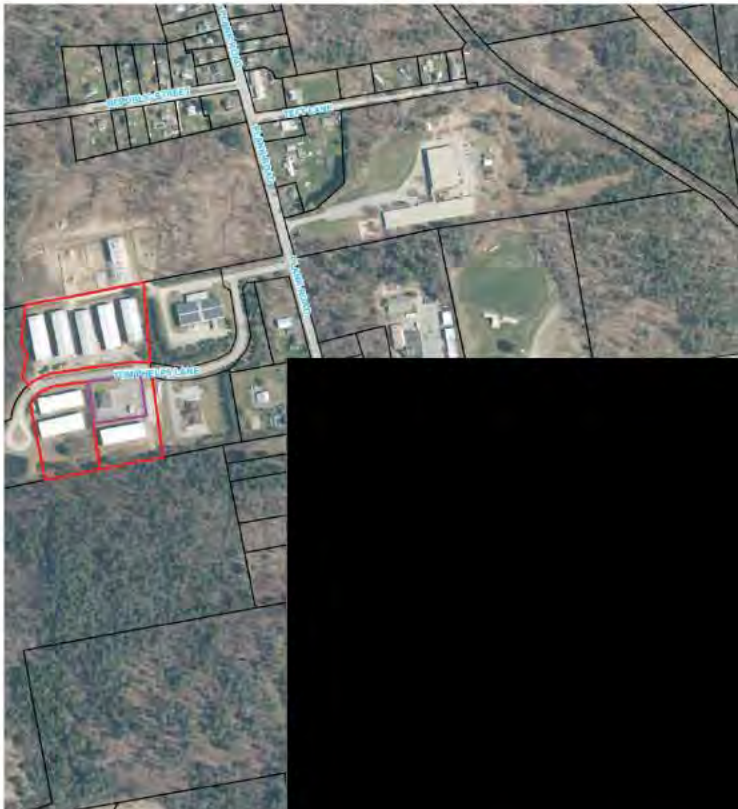
SAMPLING LOCATION

<u>Sample Number</u>	<u>Sample Location</u>
R581523-1 Garage 1	[REDACTED]
R581523-2 Garage 2	[REDACTED]
R581523-3 House 1	[REDACTED]
R581523-4 Hospice 1	[REDACTED]
R581523-5 Hospice 2	[REDACTED]

The residence is approximately 2000 ft South of the suspected distillery.
